Campbell Yacht Survey

**RECREATIONAL BOAT
REPORT OF SURVEY (CVS)
OUR FILE NUMBER: 20151015SEAHORSE52**

Prepared for: Paul Lawrance
Purpose: condition and valuation
Survey Date: 10/15/2015
Report Date: 10/15/2015
Attending Surveyor: Campbell
Owner or Representative: Marc Harris, agent Marcali Yachts
Survey Requested By: Paul Lawrance

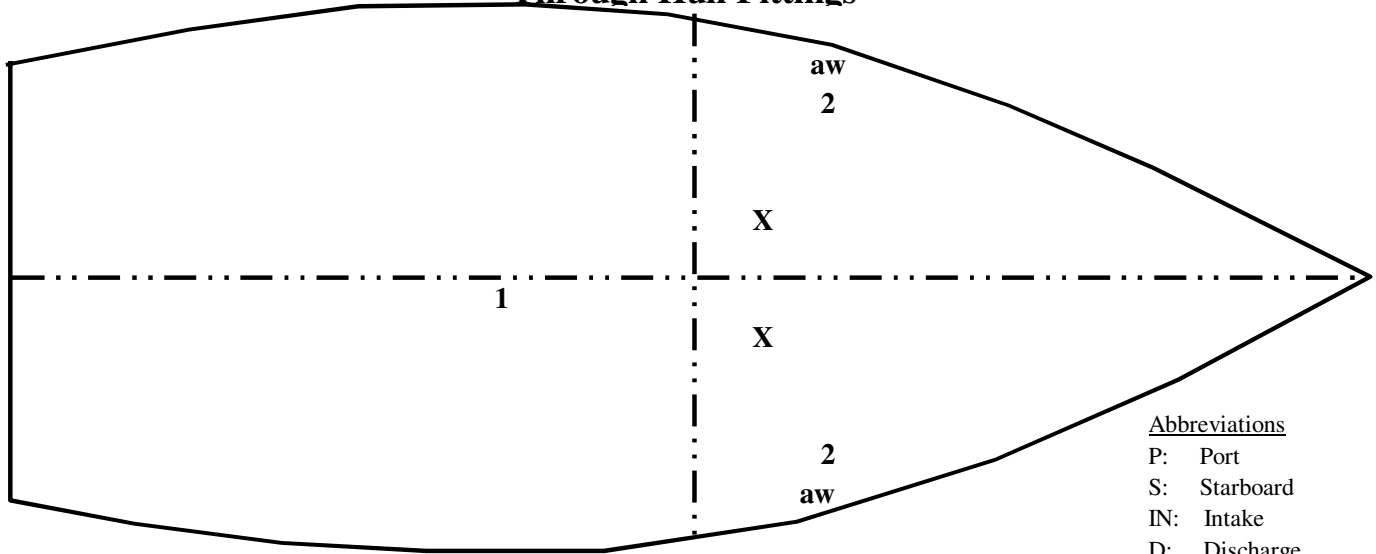
Through Hull Fittings

Location	Function	Material	Type	Bonded	Comments
1	Sea Chest	FRP SS	ball	No	clean and general service
2	Drains	Bronze	ball	No	Stiff
3					
4					
5					
6					
7
